THE REMR 19960117 075 Bulletin

October 1995

Precast concrete panels used to rehabilitate Allegheny River Lock and Dam No. 4

by Carmen Rozzi, U.S. Army Engineer District, Pittsburgh

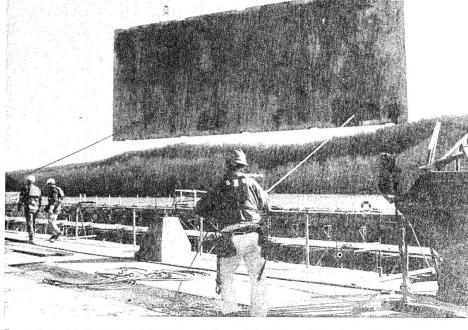
Precast panel being lowered into place during rehabilitation of Allegheny River Lock and Dam No. 4

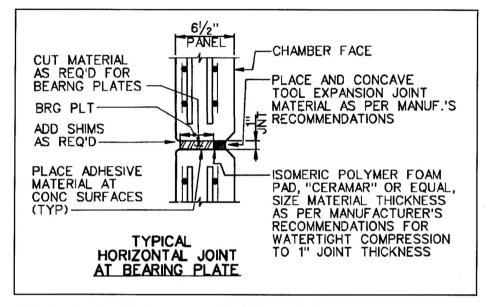
concrete surface, and was easily cut to accommodate the shimpack bearing plates (Figure 1).

Figure 1. Schematic of horizontal panel joint with bearing plate

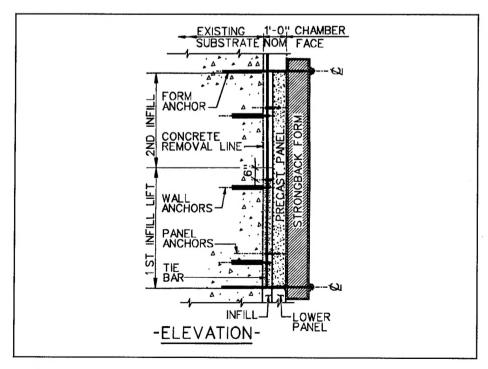
Figure 2. Temporary anchorage system

With the acceptance of the variance from the original design, a temporary strongback forming system was now required to support the precast panels during infill concrete placement. Also, a permanent system of anchorage was required. Strongbacks were double channel-braced members placed 4 ft center to center. An all-thread form anchor pinned the strongbacks in place at the top and bottoms of the panels (Figure 2).

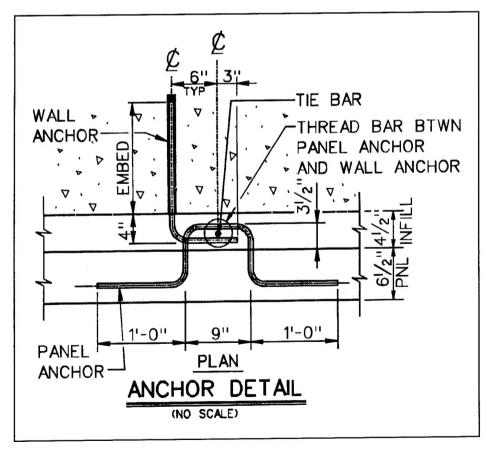
The permanent anchorage consisted of Technical Report REMR-CS-41 details. A bent 180-deg reinforcing bar (panel anchor) was embedded into the back face of the panels at an approximate 4-ft grid system to be slightly offset with 90-deg hook number 6 (wall anchors) dowels embedded into the lock wall. A number 5 (tie bar) reinforcing bar was then threaded between the panel anchor and the wall anchor (Figure 3).

Figure 3. Permanent anchorage system

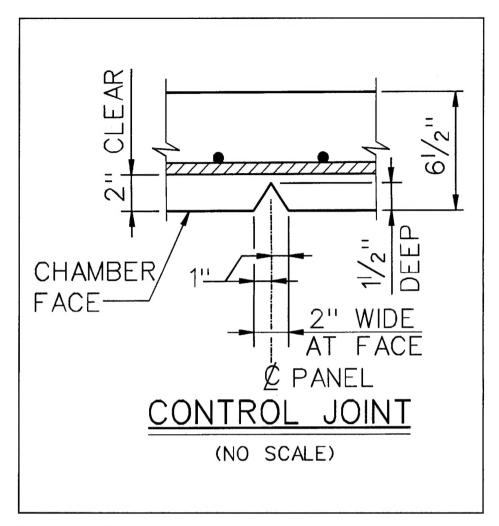
The fabrication techniques used by the Fort Miller Company for construction of the precast panels were as outlined in Technical Report REMR-CS-41 except a control joint detailed at the center of the panel was added. Observations of a distinct pattern of cracking located at the center of the panels at Troy Lock led to this addition (Figure 4).

Figure 4. Control joint added at center of panel

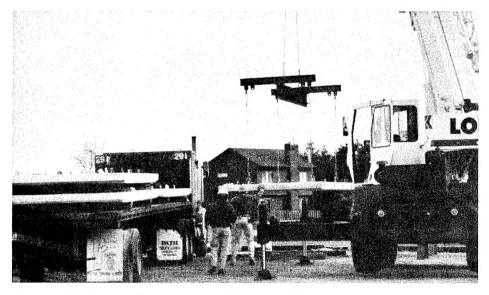
Figure 5. Contractor's jib-beam assembly used during onsite handling

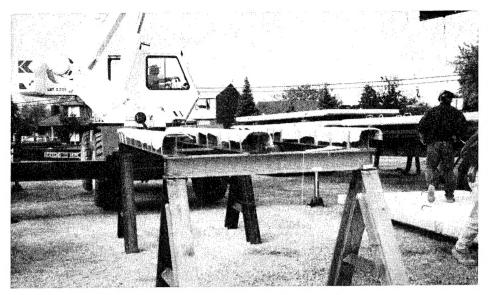
Figure 6. Steel-frame I-beam horses, used for quality-control measurements

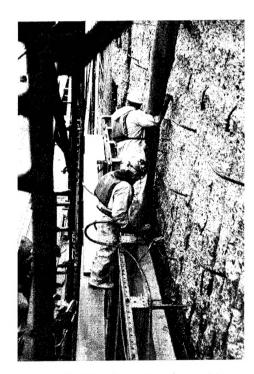
Infill concrete was placed with flexible tremie tubes (elephant trunk) (Figure 8). A concrete bucket lifted by the erection crane was used to distribute the infill concrete.

Figure 8. Flexible elephant trunk concrete chute

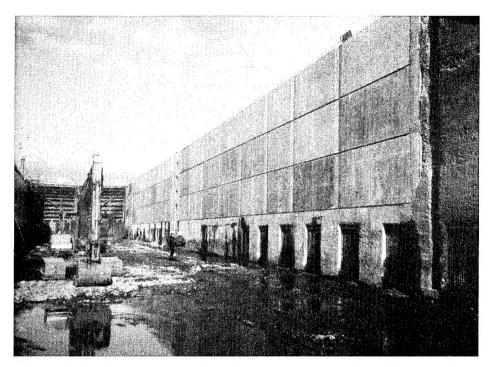
Figure 9. River wall panels, looking upstream

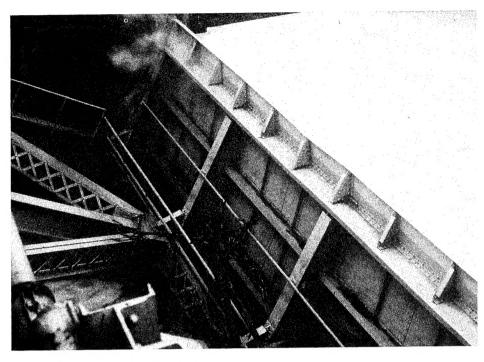
Ice buildup on tainter gates at northern locks and dams can be a serious problem. For example, ice frozen onto the upstream skinplate can prevent movement of the gate and restrict river flow control at the dam. (Sheet ice grown onto the upstream skinplate of a tainter gate at Starved Rock Lock and Dam is shown in Figure 1.) Another difficulty occurs when structural members such as trunnion arms or support channels become coated with ice from submergence in the downstream pool, from splashing, or from the atmosphere.

Figure 1. Ice grown onto a tainter gate

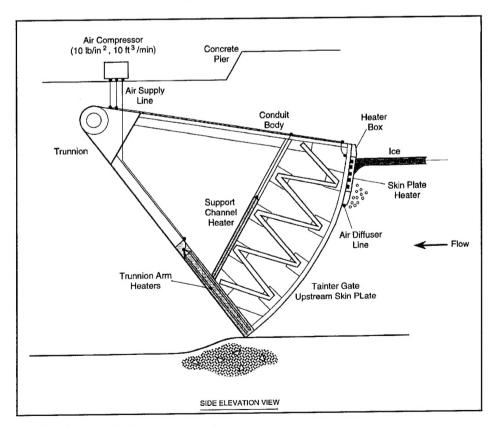
In the St. Paul District, engineers have designed heaters for tainter gates that can be used to remove ice. Heaters have been placed on four tainter gates at Lock and Dam No. 2 on the Upper Mississippi River. A typical installation is shown in Figure 2. Cartridge heaters have been placed in watertight enclosures on the upstream skinplate. Five enclosures are placed in a heater box with a total heater capacity per foot of gate width of 750 W/ft. When a gate needs to be raised or lowered, the heaters are turned on to melt the sheet ice that grows onto the front of the gate. It typically takes about 2 hr to melt about an inch of ice away from the gate so that it can be moved.

Figure 2. Tainter gate showing various heaters
